Correcting Breach (leak) Problems

2313 Harrier Run, Naples, Florida 34105 Tel: 239 263-9957

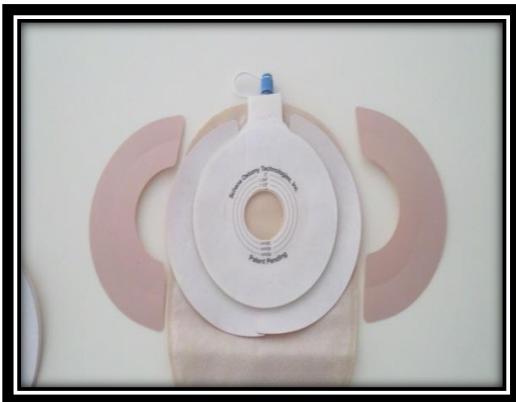
Security Tabs Applied to Outside Perimeter of the Wafer

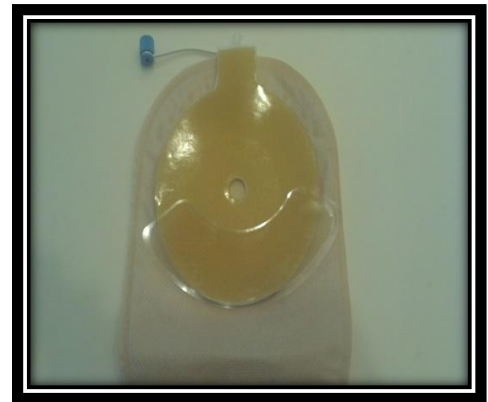
Hydrocolloid Tabs Applied to Inside Wafer Perimeter

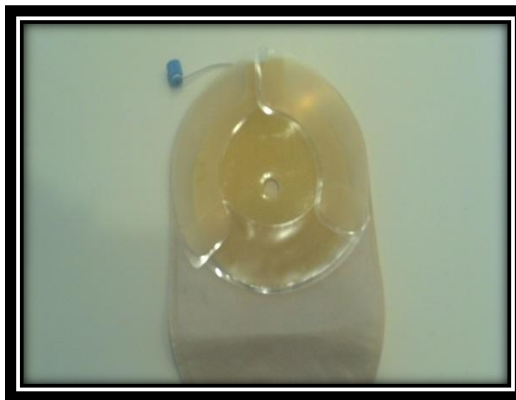
Seal Tab on Bottom 4 to 8 Clock Position

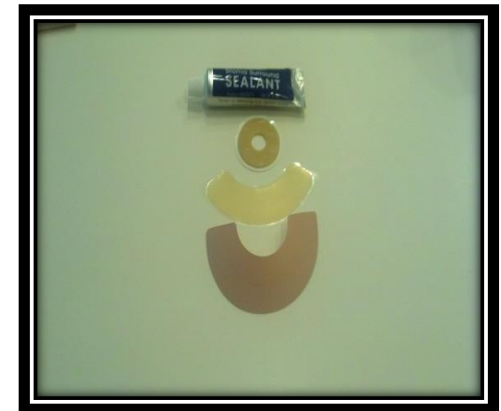
Products Used to Seal the Wafer to the Abdominal Skin Around Stoma

Schena Ostomy Technologies, Inc. products and their part numbers to use in solving breach problems:

1. Adhesive Perimeter Hydrocolloid Security Tabs P/N 10-1013 PHST

2. Stoma Seal Ring P/N 10-SSFS-13

3. Stoma Surround Sealant P/N SSS70112

4. Outside Perimeter Security Adhesive Tabs P/N 1-SST-12111
